NEA/CSNI/R(2001)12

**NUCLEAR ENERGY AGENCY
COMMITTEE ON THE SAFETY OF NUCLEAR INSTALLATIONS**

REQUALIFICATION PROBLEMS OF SAFETY RELATED EQUIPMENTS FOLLOWING OUTAGES

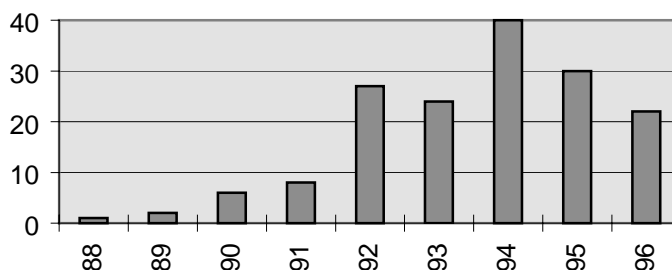
Figure 3 - Numbers of significant safety-related incidents associated with requalification.

The change in the number of significant safety-related incidents associated with requalification over the period 1988 to 1996 (figure 3 above) must be analysed to identify trends. Overall, it reflects that this particular problem has been taken into account. Problems relating to requalification were discovered in the period 1988-1990. In the period 1991-1993, measures taken by EDF⁴ became more widespread and bolstered requalification. The increase in incidents can be partly explained by the growing number of power plants. The decrease from 1995 corresponds to the year in which the EDF's proposed measures were supposed to start taking effect.
