INPO 11-005
November 2011

Special Report on the Nuclear Accident at the Fukushima Daiichi Nuclear Power Station

Revision 0

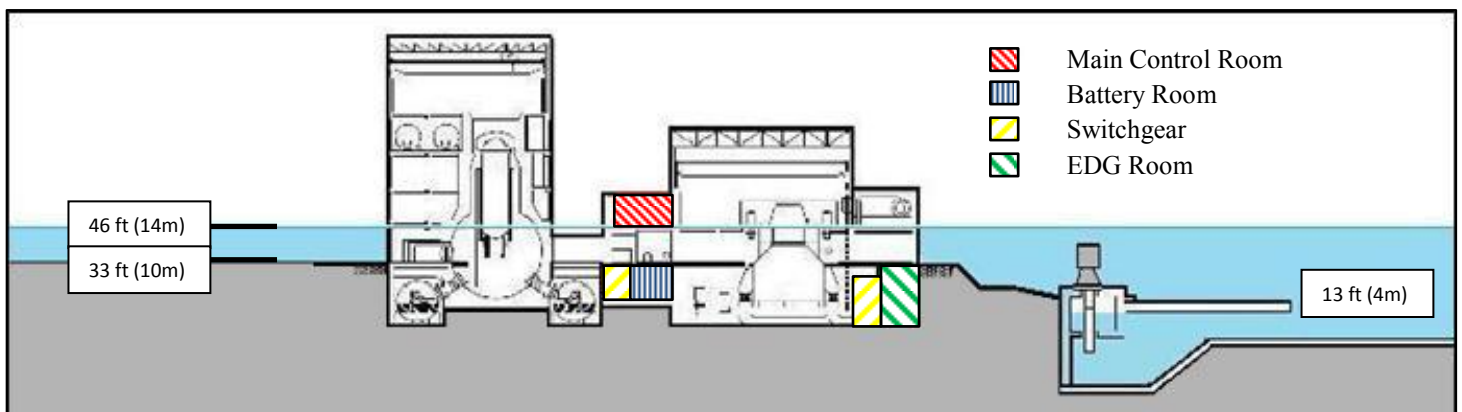
Figure 3.3-1 General Elevations and Inundation Level

The tsunami inundated the area surrounding units 1–4 to a depth of 13 to 16 feet above grade (4 to 5 meters), causing extensive damage to site buildings and flooding of the turbine and reactor buildings. Intake structures at all six units were unavailable because the tsunamis and debris heavily damaged the pumps, strainers, and equipment, and the flooding caused electrical faults. The damage resulted in a loss of the ultimate heat sink for all units. The diesel generators operated for a short time; but by 1541, the combination of a loss of cooling water, flooding of electrical switchgear, and flooding of some of the diesel generator rooms (located in the basement of the turbine buildings and not designed to withstand flooding) caused a loss of all AC power on site for units 1–5. (Refer to Figure 7.4-7.)

Figure 3.3-1 shows the general elevations (typical for units 1–4) and the approximate inundation level. The grade level of units 1–4 is 32.8 feet (10 meters) and is 42.7 feet (13 meters) at units 5 and 6 above mean sea level (commonly referred to as OP, for the level in the Onahama Port). The intake structures were at an elevation of 13.1 feet (4 meters) for all units.

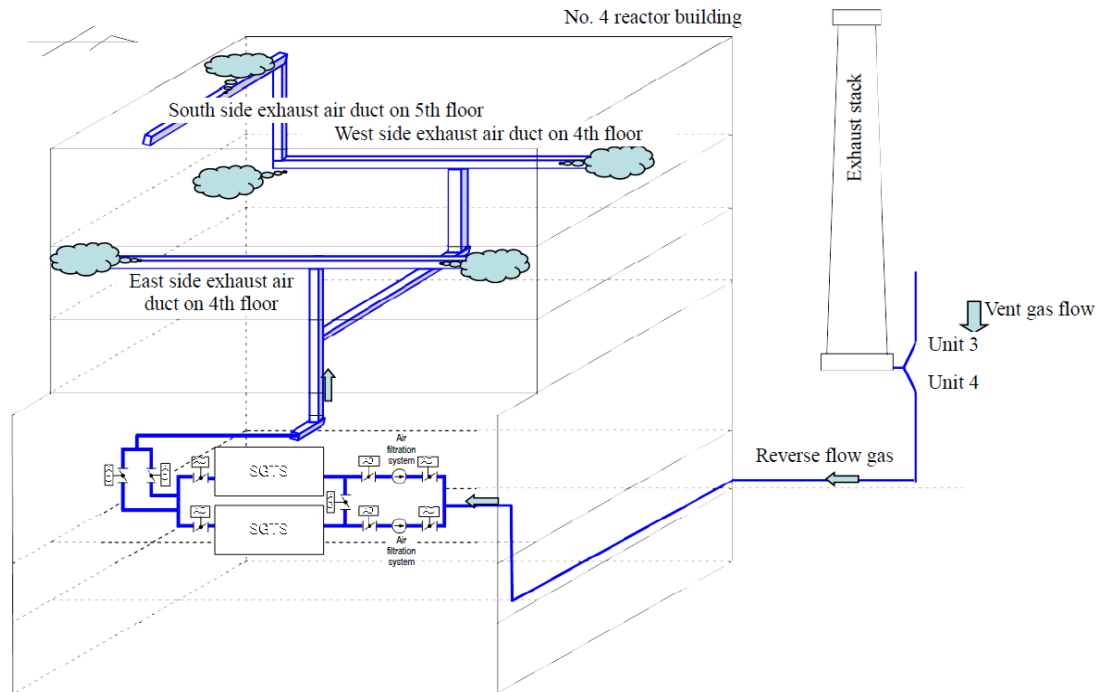
Figure 4.4-1 Unit 4 Standby Gas Treatment System Hydrogen Flow Path

The most widely accepted theory is associated with the backflow of gases from Unit 3 during venting. The containment vent exhaust piping from Unit 3 is connected to the Unit 4 exhaust piping. The dampers on the Unit 4 standby gas treatment system (SGTS) are air-operated and fail open on a loss of power or air (except the cross-connect between SGTS filter trains). Additionally, the system does not have a backflow damper installed in the piping that connects to Unit 3. With no power or air, and no fans in service to direct the gases from Unit 3 up the exhaust stack, the exhaust gases from Unit 3 would be directly aligned to the Unit 4 SGTS filters. This piping arrangement may have allowed

gases from the Unit 3 containment to be vented to the Unit 4 reactor building via reverse flow through the Unit 4 standby gas treatment system.

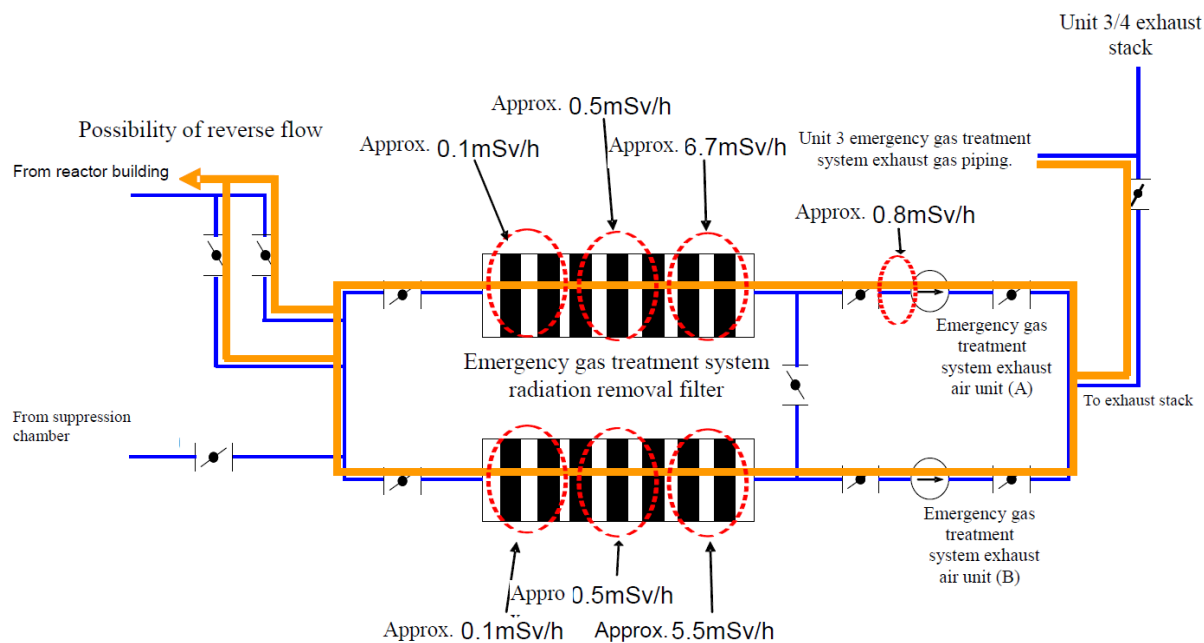
Figure 4.4-2 Unit 4 Standby Gas Treatment System Filter Survey Results

To confirm this theory, on August 25 TEPCO personnel performed radiation surveys on the Unit 4 SGTS filters. The survey results, shown in Figure 4.4-2, revealed higher radiation levels at the locations closer to Unit 3. These survey results support the conclusion that there was backflow from Unit 3 to Unit 4. Further inspections are needed to confirm this theory; but based on this information, it is postulated that the hydrogen explosion in the Unit 4 reactor building was caused by hydrogen from Unit 3.

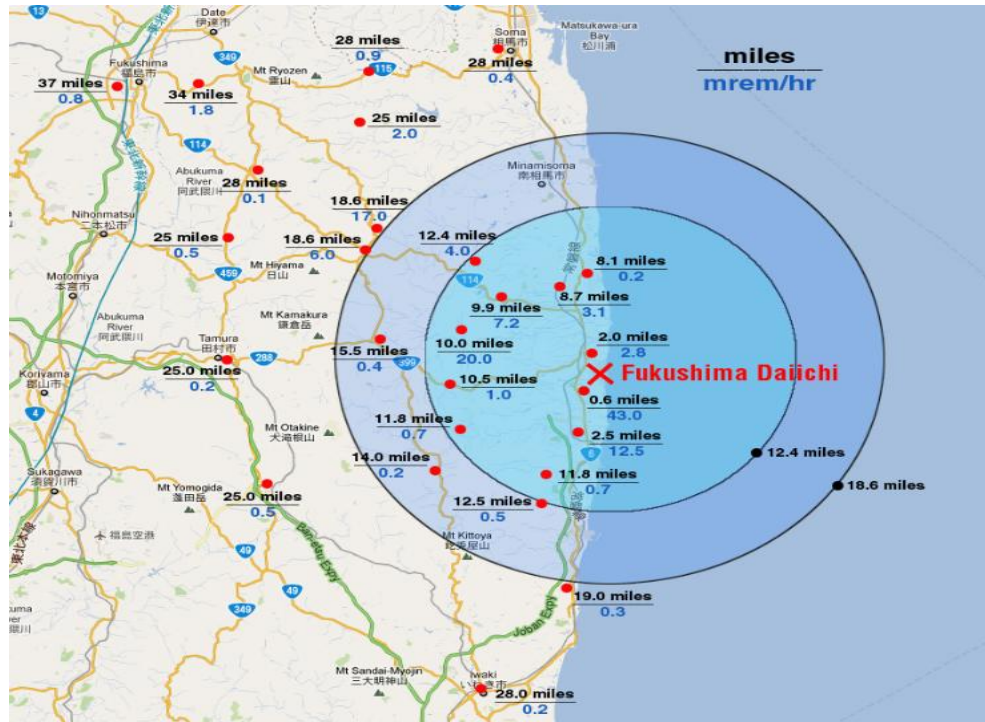
Figure 5.4-1 Initial Off-Site Survey Results

Routine dose rate surveys began to be collected in the area outside the 12.4 mile (20 km) radius of the plant on March 16. The highest dose rate of 17 mrem/hr (0.17 mSv) was measured 19 miles (30.5 km) northwest of the station. The first air samples from the site boundary, on March 22 and 23, had iodine-131 concentrations that were equivalent to approximately 80 mrem (0.8 mSv) of thyroid dose each hour if inhaled by an unprotected individual. The concentration remained between 25 and 200 percent of this value until April 18, 2011. Surveys inside 12.4 miles (20 km) began on March 30. The map shown in Figure 5.4-1, which was created based on survey results, is representative of these initial surveys.

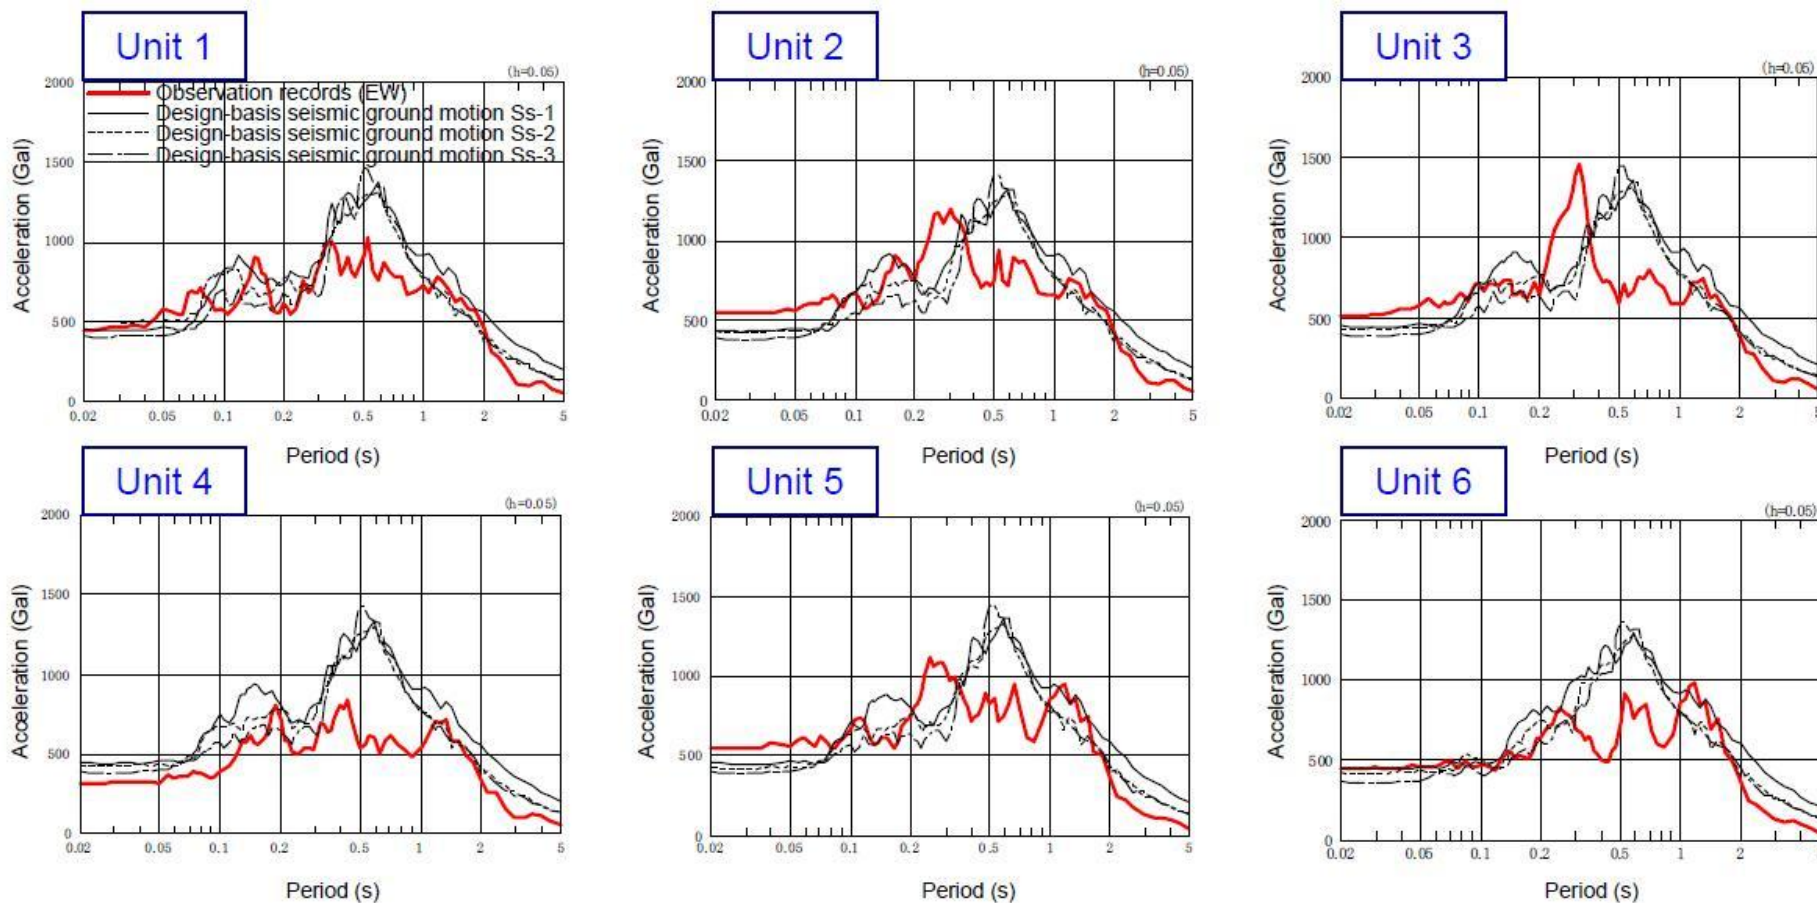
Figure 7.1-1 Preliminary Seismic Data

While no formal seismic walkdowns have been performed, a review of plant indications and operator logs does not indicate any seismic damage that affected the operator response to the earthquake. Before the tsunami, all emergency diesel generators that were operable started and loaded as expected, and each emergency core cooling system the operators used appeared to function as designed. Reactor pressure, reactor water level, and containment pressure indications for units 1, 2, and 3 appeared as expected following a scram and did not indicate any potential breach of the reactor coolant system from the earthquake.

Graphs indicate the observed values as compared to the design basis seismic criteria.
