*Corine PIEDAGNEL - François TARALLO – Bernard MONNOT*  
*Institut de Radioprotection et de Sûreté Nucléaire*

## Flamanville 3 EPR

Safety assessment and on-site inspections

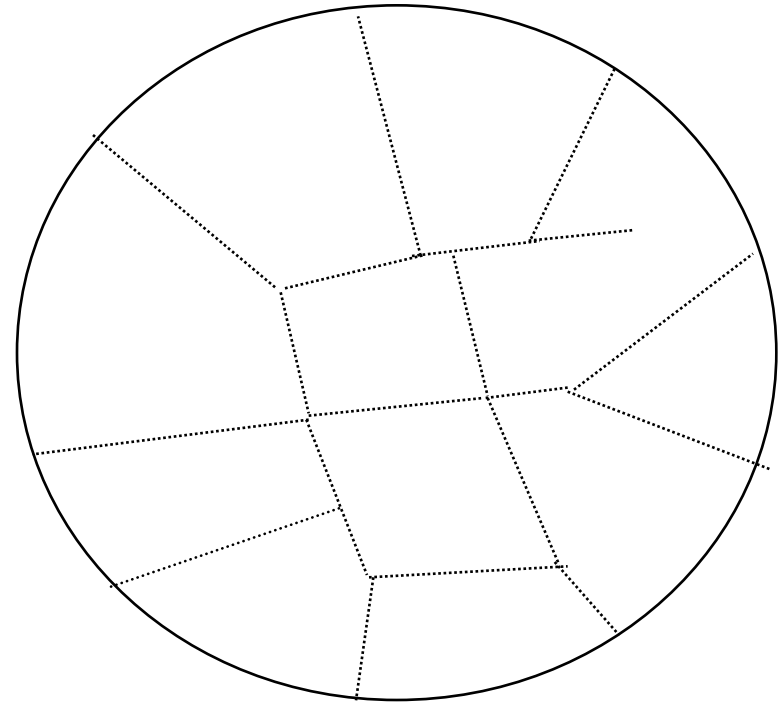
- December 2007: concreting for first time of common basemat on nuclear island under the reactor building (4225 m<sup>3</sup>, thickness 1.8 m)
- Several days later: open cracks of 1 mm to 3 mm
- After cooling: open cracks of 0.4 mm to 1 mm
- Repair: injection of cracks

Configuration of cracks in the circular basemat

- Cause of this non-conformity:
  - thermal effect due to the heat of hydration of the cement during concrete setting (expansion and contraction due to exothermic reaction)
- Aggravating circumstance:
  - lack of reinforcement mesh in the upper part of the lift
- Risk:
  - reduced durability of the structure;
  - possible corrosion of the bottom reinforcement even if cracks are grouted;
  - presence of water below the basemat should be detected during the lifetime of the plant.

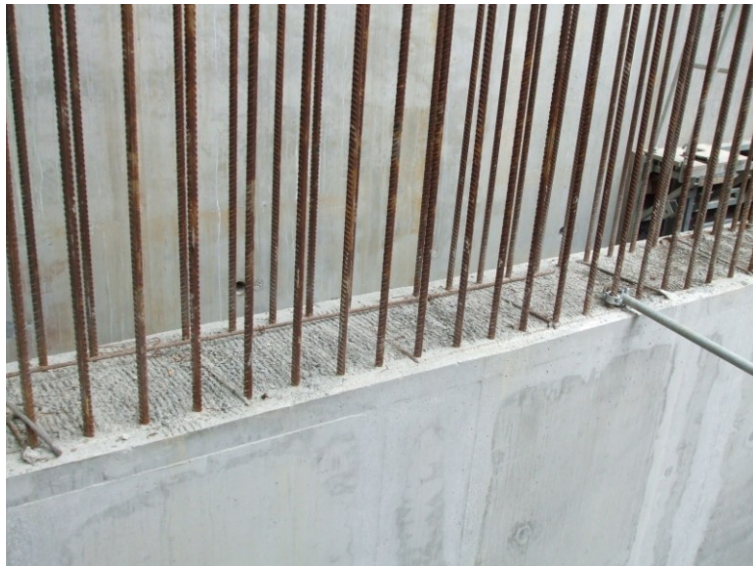
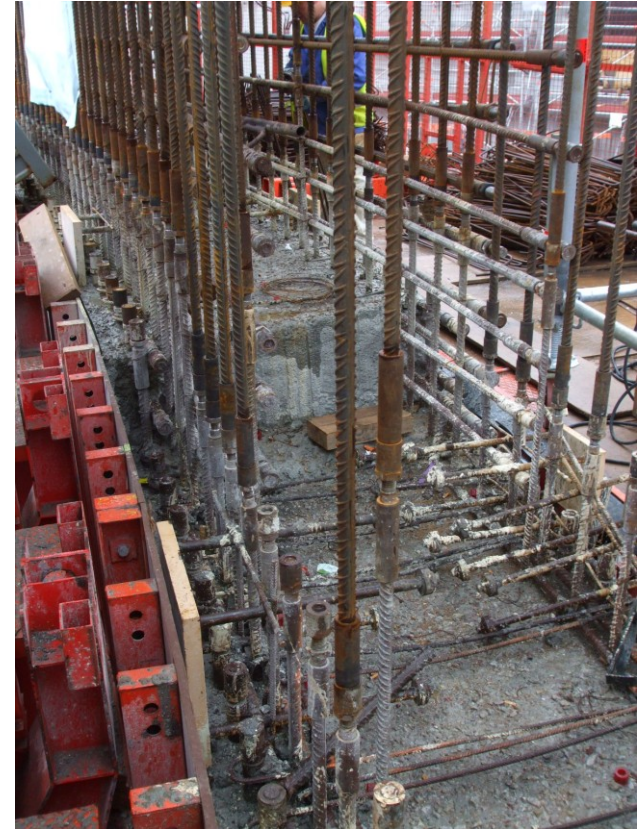
- Site practice seen during 4 inspections
  - Gusset -6.25 m : no treatment
  - Rake
  - Deactivator

Examples of concreting joints

- IRSN Technical assessment >> ASN letter sent to EDF
- An unsatisfactory treatment of construction joints can lead to lower quality joints which jeopardize construction quality:
  - Robustness of structures;
  - Durability (faster than expected steel reinforcement corrosion).
- Structures are not conform to design hypothesis: design margins and expected lifetime can be lower than previewed.
- IRSN asks dedicated structural verifications, taking into account awkward joints treatments.

- EDF actions :
  - stopped using one of the « deactivators »;
  - undertaken a dedicated test program;
  - strengthened its survey in that field.
