Appendices 1 to 4 to PISC II Report No. 3

# **X-Ray Examination of the PISC II RRT Plates Before Destructive Examination**

Programme for the Inspection of Steel Components

## X-Ray examination of the PISC II RRT plates

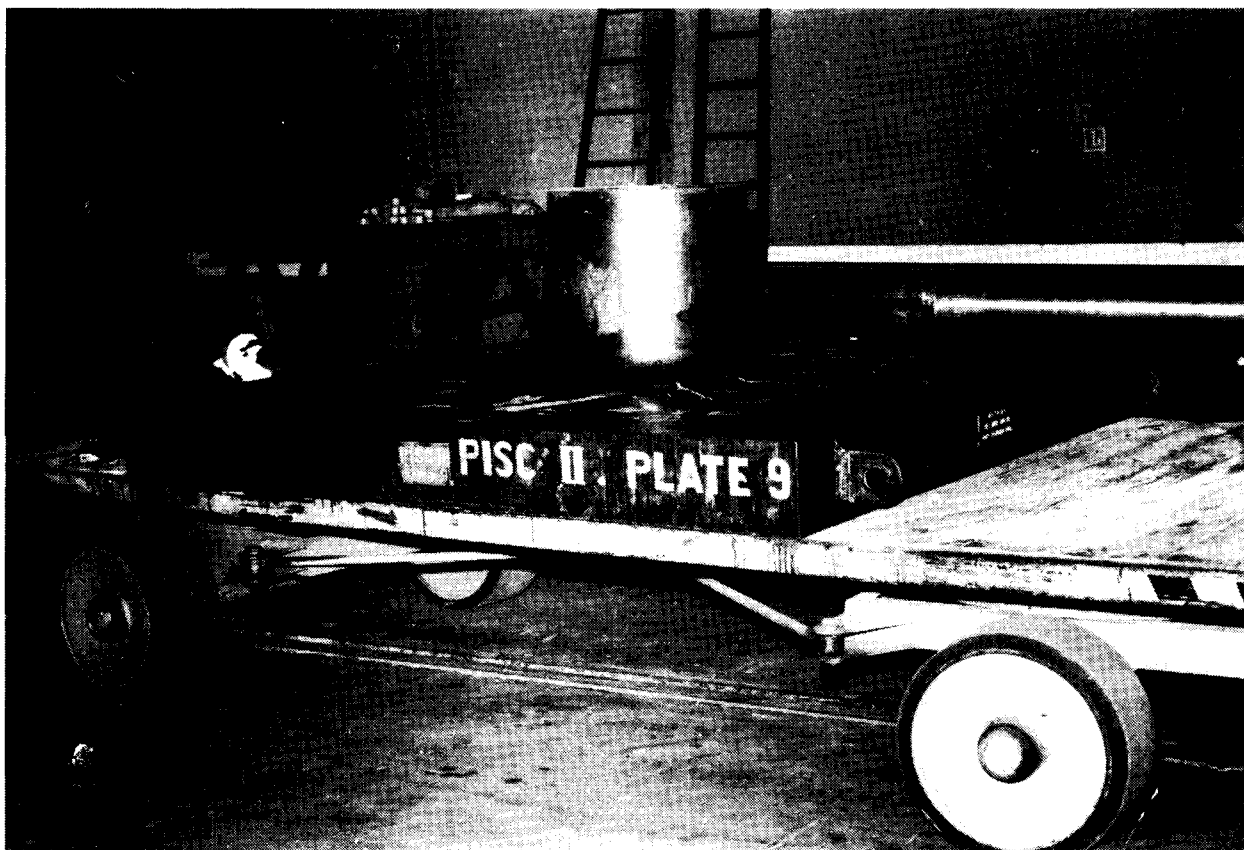
Fig. 4      Plate No. 9

### X-Ray examination of RRT plate No. 9 (see Fig. 4)

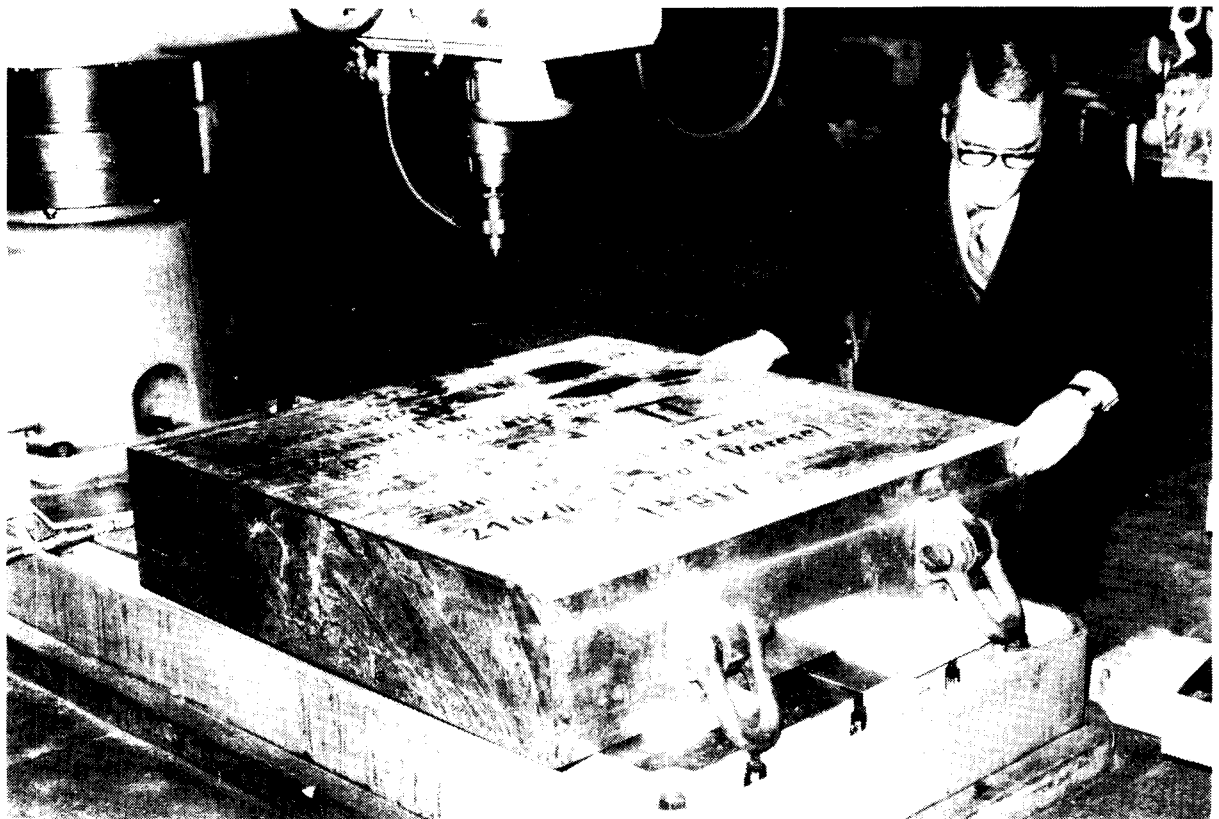
Fig. 10 Plate No. 1

Plate No. 1 of the PISC II RRT is shown in Fig. 10.
