International Workshop on Post-Accident Food Safety Science, 8-10 November 2016, Fukushima Japan

Radiological Release Caused by the Accident, and Status of Contaminated Areas

SHINJI OIKAWA

Radiation Monitoring Division,
The Secretariat of the Nuclear Regulation Authority
(welcome our web site: <http://www.nsr.go.jp/english/index.html>)

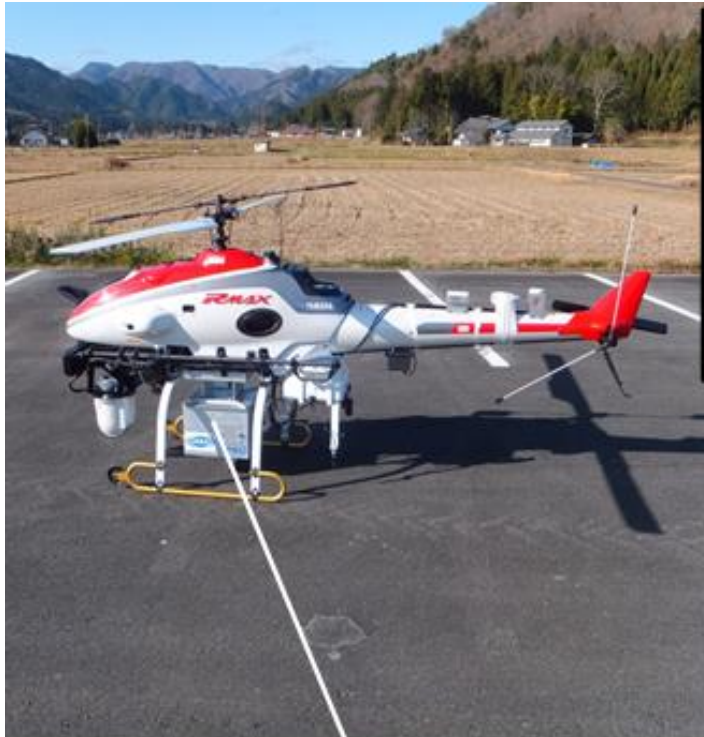
Surveys with a radio-controlled helicopter (an unmanned helicopter), equipped with a LaBr₃(Ce) scintillation detector

無人ヘリ搭載用放射線測定器の概要

- 検出器 (LaBr₃(Ce)検出器)
(38mm φ × 38mmH × 3本)
 - 検出範囲 : 0.01 ~ 0.1mSv/h
 - 検出エネルギー : 60keV以上
 - データ収集周期 : 1回/秒
 - 測定器重量 : 約 8.0kg (筐体含む)

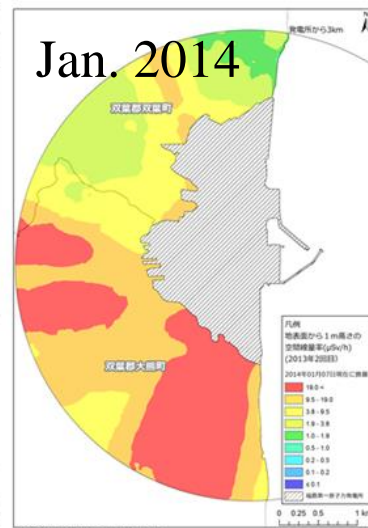
The time course of the environmental radiation rates ($\mu\text{Sv/h}$) at the 1m above the ground obtained by a radio-controlled helicopter (Oct. 2012 to Oct. 2015)

第1回 2012年10月20日に減衰補正

第2回 2013年3月20日に減衰補正

第3回 2013年7月31日に減衰補正

第4回 2014年1月07日に減衰補正

第5回 2014年7月22日に減衰補正

第6回 2015年1月15日に減衰補正

第7回 2015年10月22日に減衰補正

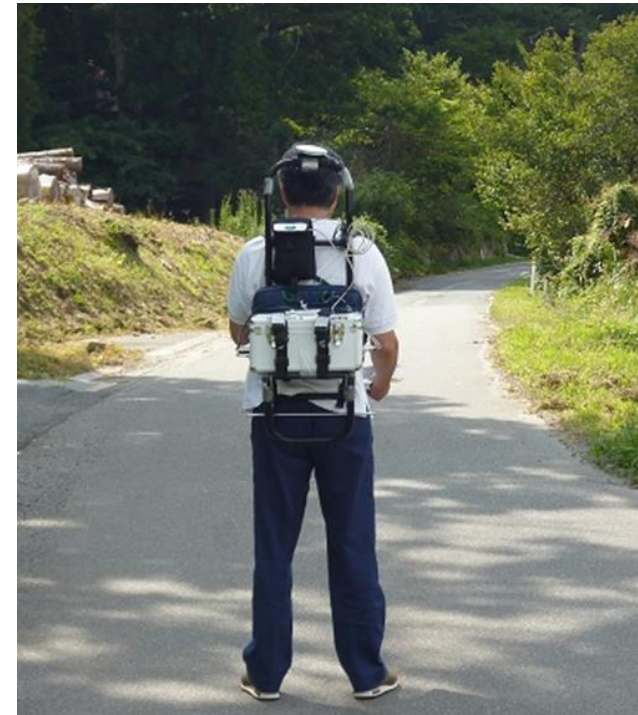
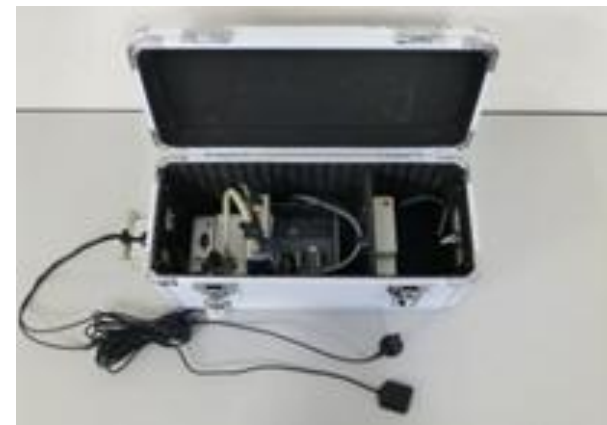
Walking survey, it is a type of complementary environmental radiation survey with vehicle-borne and Air-borne surveys.

Environmental radiation detectors
(KURAMA-2 system)

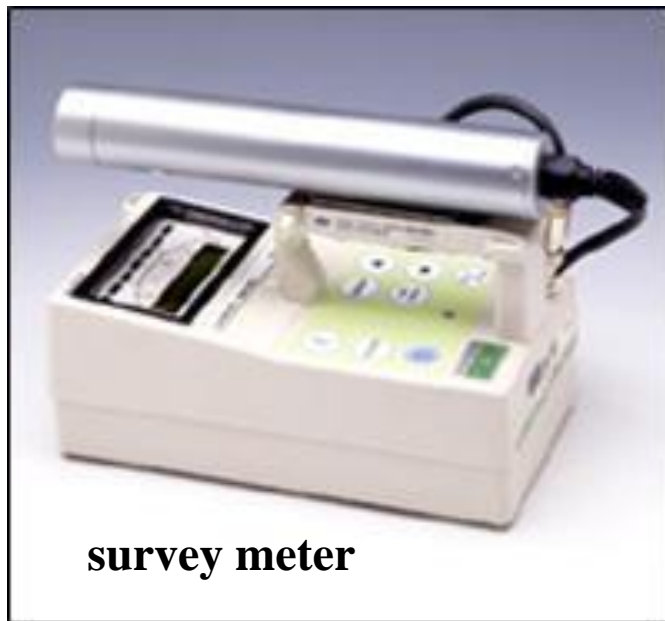
Monitoring is conducted by survey meters on the flat area which has not been disturbed by human activities as shown in the following photos.

survey meter

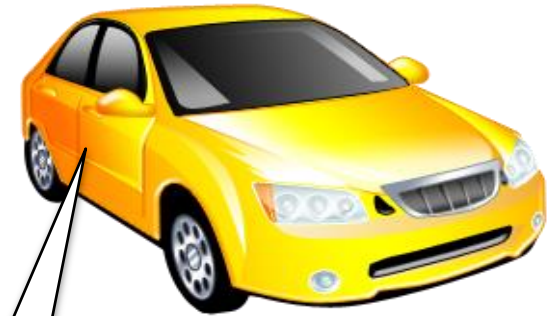
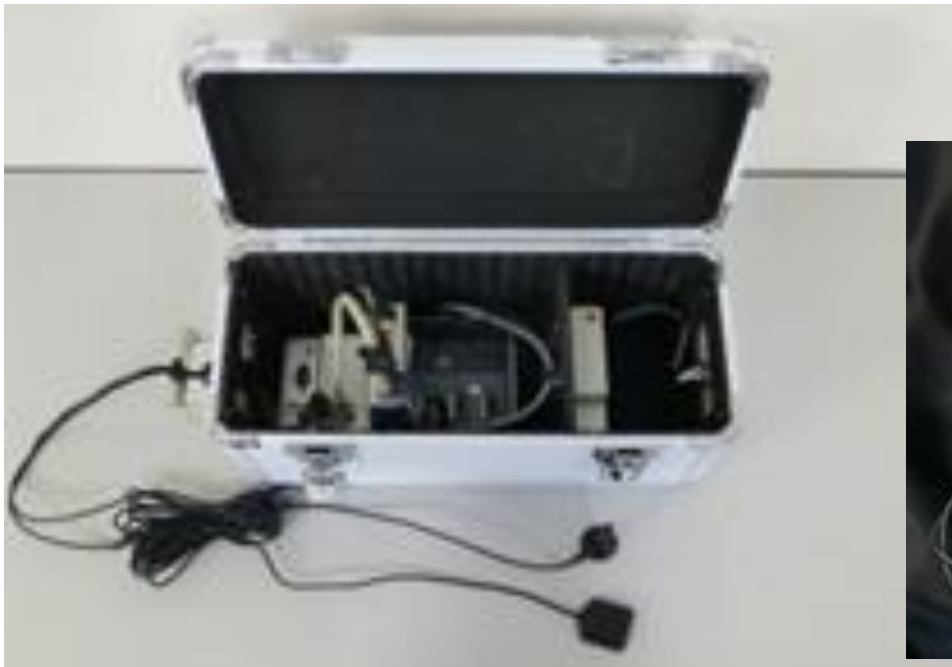
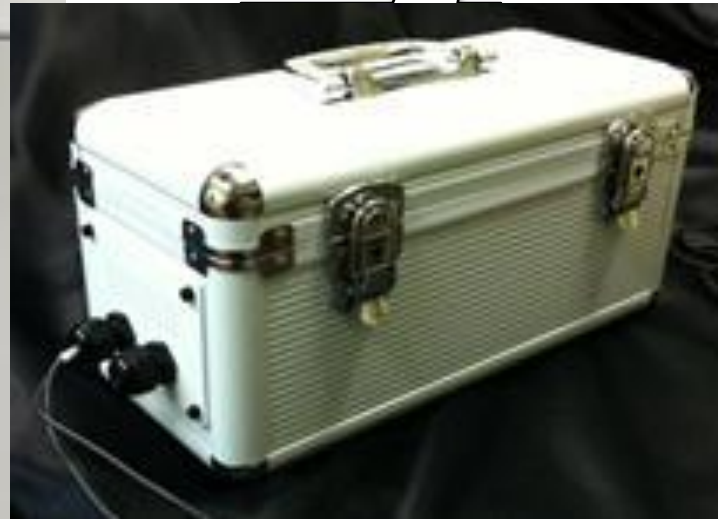
Monitoring is conducted by mobile type radiation detectors (KURAMA-2 system) equipped in vehicles.

Environmental radiation detectors
(KURAMA-2 system)

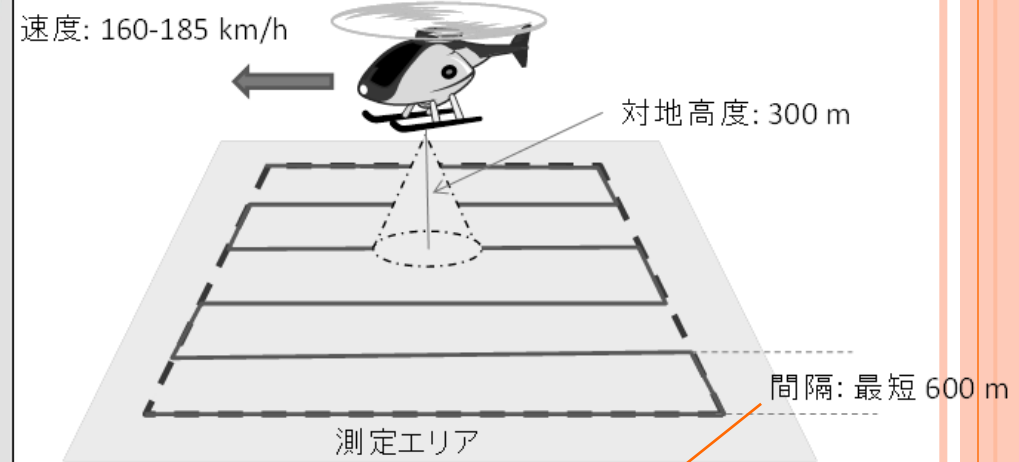
<Flight Intervals>

- 1.85 km: Area of $< 0.2 \mu\text{Sv/h}$ (measured previously);
- 0.93 km: Area of $\geq 0.2 \mu\text{Sv/h}$ (measured previously) (except Evacuation Directed Zones);
- 0.62 km: Evacuation Directed Zones
