INPO 11-005
November 2011

Special Report on the Nuclear Accident at the Fukushima Daiichi Nuclear Power Station

Revision 0

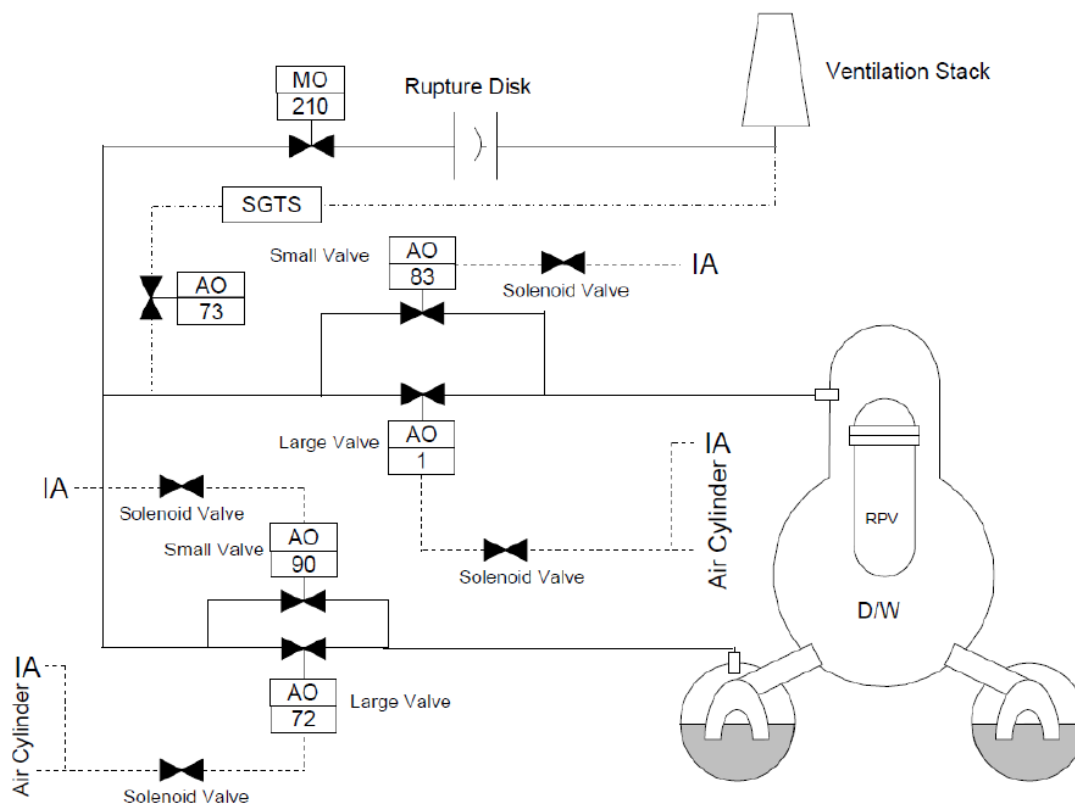
Figure 7.4-4 Overview of Unit 1 Containment Vent System⁹

Between 1999 and 2001, TEPCO modified the design of the containment vent system by adding new vent pipes extending from the suppression chamber and drywell to the stacks. These vent pipes were added to provide a method of venting containment during severe accidents. The modified ventilation piping bypassed the standby gas treatment system (SGTS) to allow operators a method of venting containment even when the pressure is high. The piping connection with the ventilation stack is provided with a rupture disk. (See figures 7.4-4 and 7.4-5.)

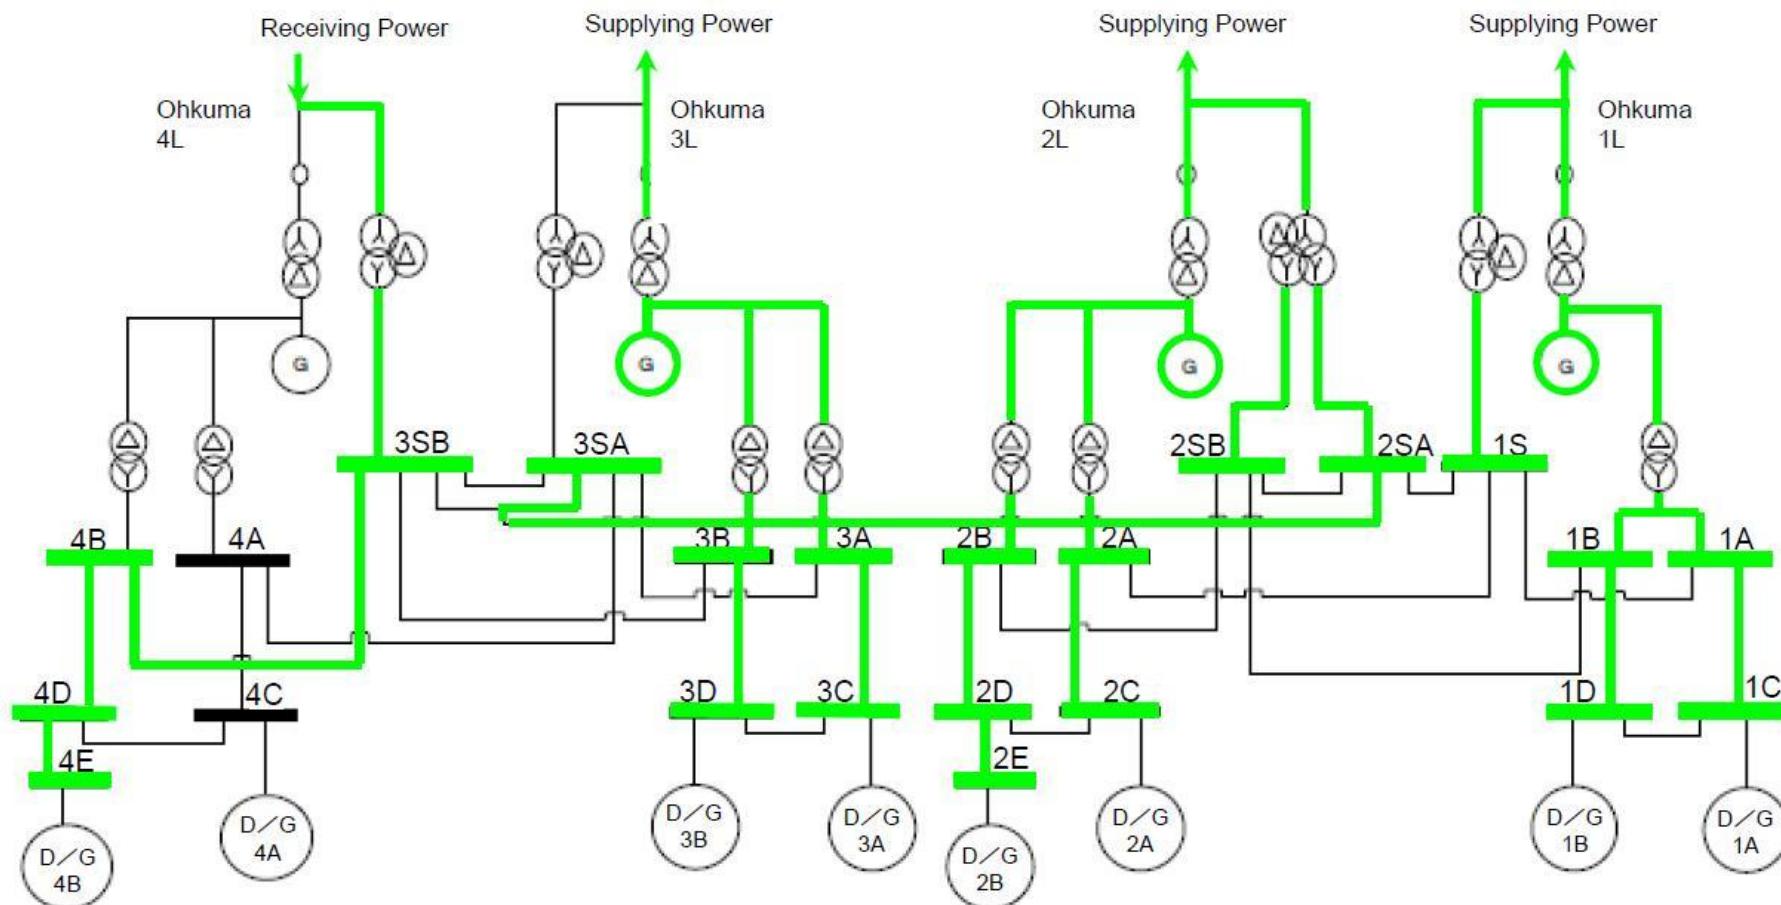
Figure 7.4-6 Simplified Electrical System¹¹

Systems highlighted in green were in service (energized). The 4A EDG and Unit 3 startup transformer were out of service for planned maintenance at the time of the event.
