# **H**heavy Load Accidents in Nuclear Installations

**Working Group on Operating  
Experience (WGOE)**

**NUCLEAR ENERGY AGENCY  
COMMITTEE ON NUCLEAR REGULATORY ACTIVITIES**

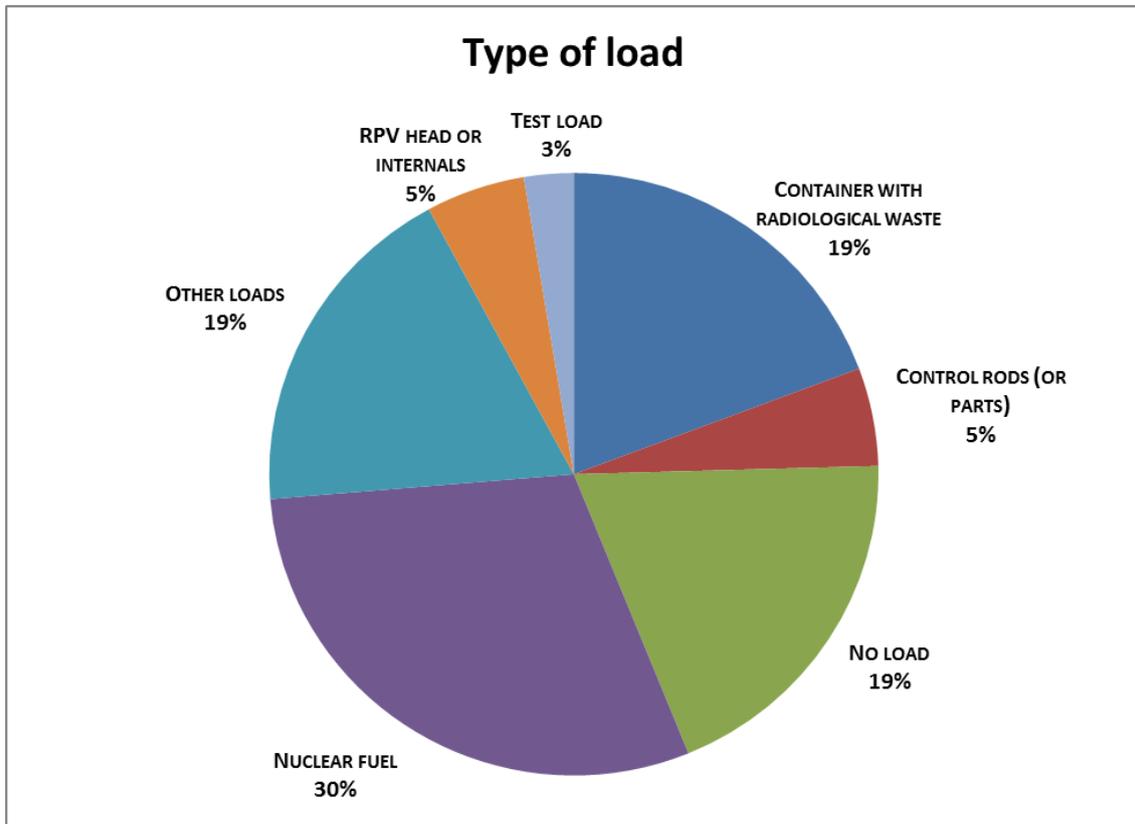
Figure 1: Distribution of events by type of load

Not surprisingly, nuclear fuel is the load most often involved. Refuelling operations in light water reactors involve many fuel assembly handling operations, and whenever an event occurs, the chances of being reported are higher if the load is a fuel assembly rather than a conventional load posing no radiological or criticality hazards.

Another load type frequently involved in events reported is the container with radiological waste. These events consist of dropping of heavy loads such as casks and containers.

In the cases where no load was involved, most often the event was related to structural failures caused by design deficiencies, generally discovered during inspections or testing of lifting devices.

Loads may be grouped into 4 main categories: nuclear fuel (most often LWR fuel assemblies, but also single fuel rods or other types of fuel used in other reactor types), reactor pressure vessel (RPV) head or internals, containers with radiological waste (often irradiated parts) and control rods assemblies (or parts of control rod assemblies). Furthermore, some events did not involve any load (for instance when the event occurred during unloaded operation, or as a result of crane inspections or design reviews), or involved test loads and two additional categories were created for these cases. All other events where the load could not be determined or did not fit into any of the preceding ones were grouped under “other loads”.

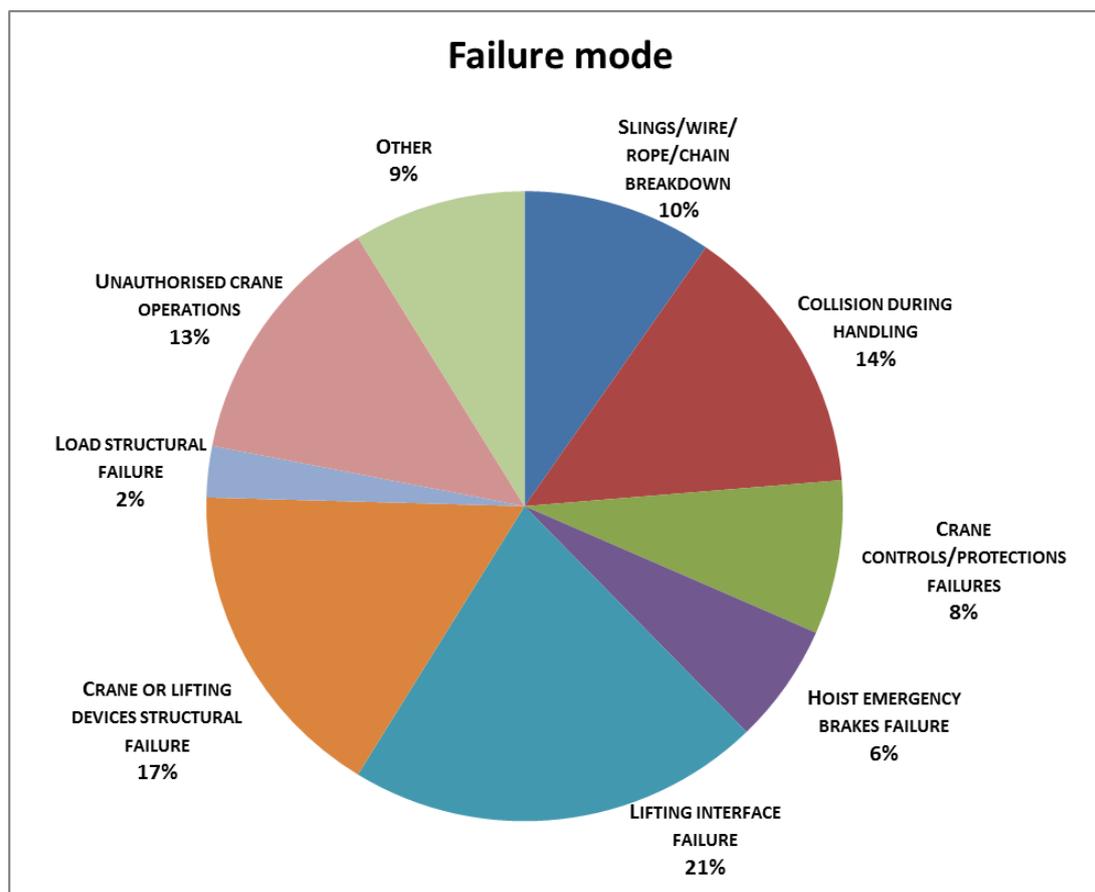
Figure 2: Distribution of events by failure mode

The “Lifting interface failure” (24 reports) is dominated by events with containers and nuclear fuel assemblies. In most events, the gripper disengaged from the fuel assembly or container, for different reasons.

The “crane or lifting devices structural failure” (19 reports) includes many events revealed during engineering design reviews or crane tests, which explains why in most cases no load was involved, and only potential consequences are described. However, this group includes also the actual collapse of the heavy lifting system during lifting of the main generator stator at Arkansas Nuclear One site in 2013.

Collisions during handling (16 reports) occurred mostly on nuclear fuel handling, and nearly always the direct cause was an operational error.

There are cases where misunderstandings among staff led the crane operator to start handling loads in unsafe conditions, or with loads exceeding the maximum allowable weight. These reports make up most of the “Unauthorised crane operations” category (15 reports).

Out of the reports classified as “Slings/wire/rope/chain breakdown” (11 reports), 3 involved containers and 3 involved fuel assemblies. In some cases the breakdown was caused by fatigue (sometimes linked to chaffing or twisting), or by the use of improper, unqualified slings.

In the case of the group “Load structural failure” (3 reports), all 3 events involved nuclear fuel. In one case a rupture in the fuel element’s central-water channel caused the fuel element to separate in 2 parts with the fuel assembly upper tie plate and the fuel channel remaining in the gripper.

Eight different main failure modes have been identified, covering more than 90% of the events.

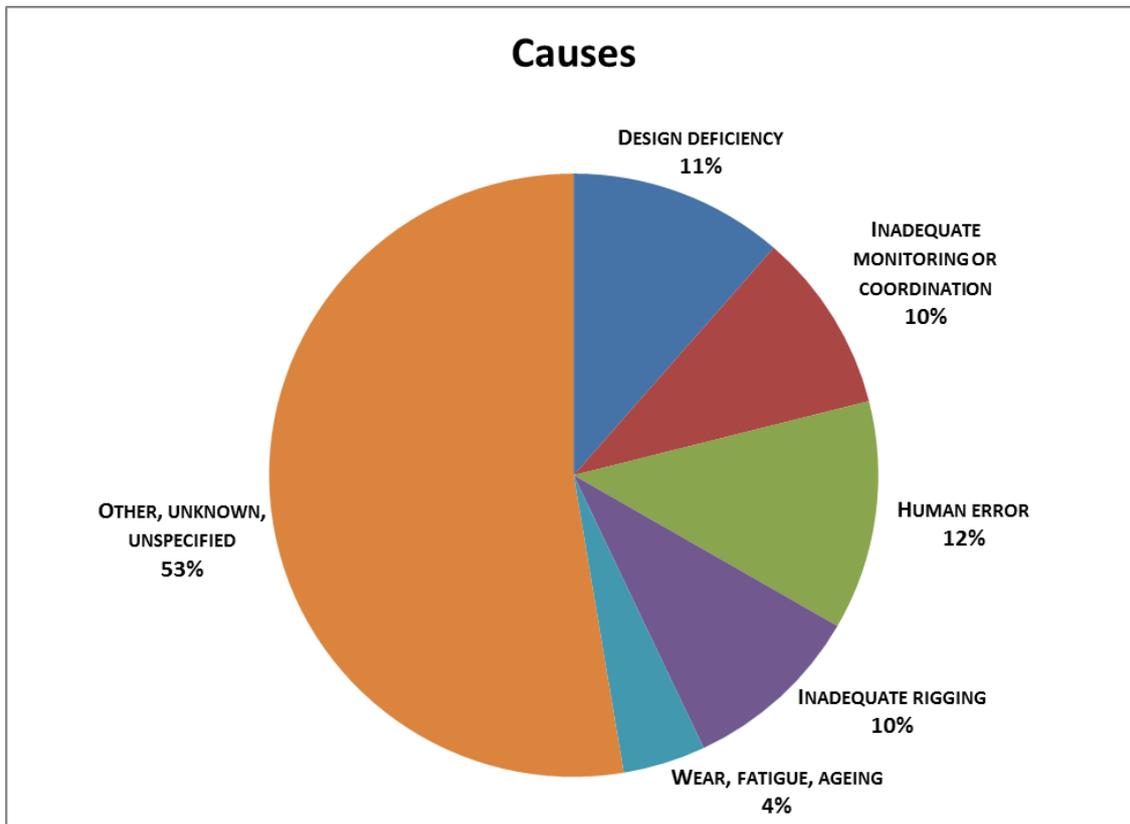
Figure 3: Distribution of events by cause

However, as the review of the events was limited to the summary descriptions, the root cause remains unknown or unspecified in more than 50% of the cases.

Human error is mentioned as root cause in 14 event reports. Six of them describe collisions during handling and other 6 unauthorised crane operations.

Design deficiencies lie behind many of the crane structural failures (actual or potential). It is worth mention that most of these events have been reported by the United States, including 7 events described by the Nuclear Regulatory Commission (NRC) Information Notice 2014-12 (crane and heavy lift issues identified during NRC inspections).

Most of the events within “Inadequate monitoring or co-ordination” are related to lifting interface failures (5 events) and collision during handling (3 events).

When “Inadequate rigging” was the cause of the event, nuclear fuel and containers were involved in 7 out of 11 cases, and the failure mode was “lifting interface failure” in 7 out of 11 cases.

Where known, the causes of the events have been classified into 5 different groups.
